Impact Assessment Report
DROUGHT PRONE AREA PROGRAMME (DPAP)
DPAP-BATCH-I

Medak District, Andhra Pradesh

Resilient Dryland Systems

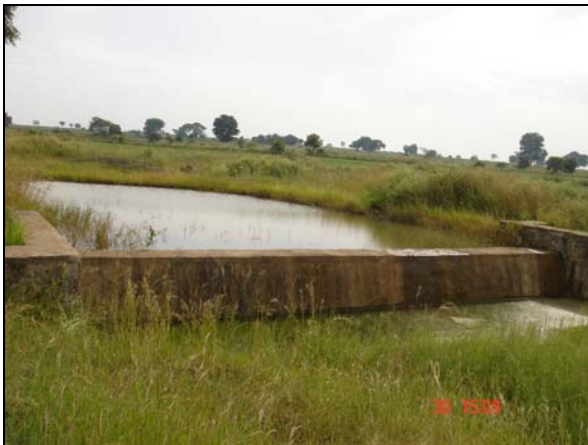
- Masonry check dam with 12 m body wall length, 1 m height was seen with storage capacity of about 350 m³ but no wells and beneficiary farmers exist in the vicinity.
- A small check wall was inspected which has been constructed for people movement to near by fields over a small stream is also storing some water.
- No wells exist in the down stream area of the structures as the soils are black and water is useful for cattle drinking & pesticide sprays.

Picture 3. A masonry check dam with Good storage of water at Aksanpally

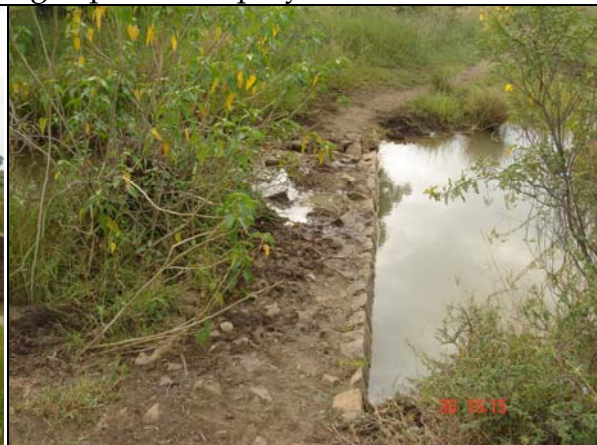
Picture 4. A check wall across a drain to store water and people to cross over it.

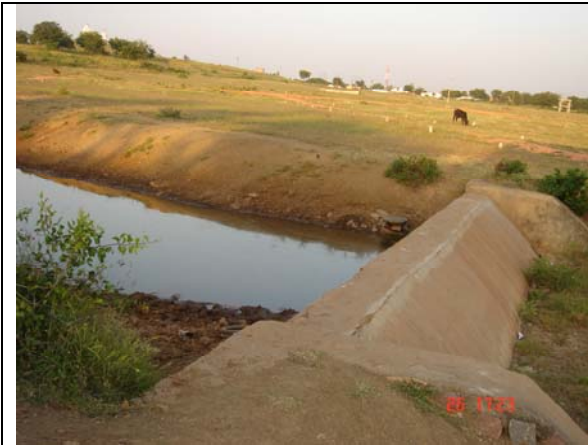
- Masonry check dam with 12 m body wall length, 1 m height was seen with storage capacity of about 600 m³ but no wells and beneficiary farmers exist in the vicinity.
- Gully control structures are damaged and no maintenance of the structures.
- Mango orchard, backside of Dhaba on Mumbai national highway was seen and it was mixed plantation with teak and other plants with irregular spacing.
- Side by land near check dam is converted into residential plots.

Picture 5. A masonry check dam in Budera watershed along with converted land in to residential plots.

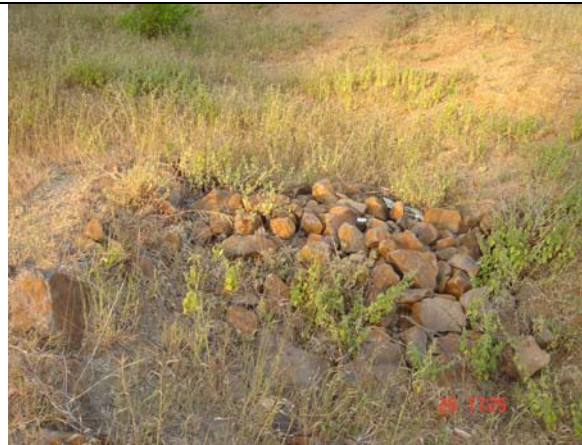
Picture 6. Damaged loose boulder structure in Budera watershed.

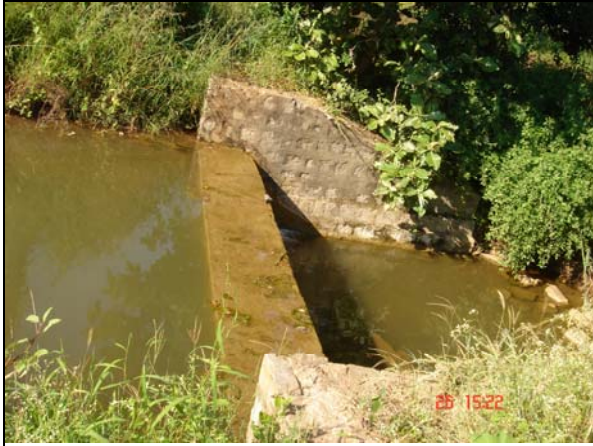
- Masonry check dam with 5 m body wall length, 1.25 m height was seen with storage capacity of about 400 m³. It is a good structure with full of overflowing water. Apron wall is damaged. There are about five wells with five beneficiary farmers and area benefited is about 8 ha. GWL is increased by about three feet and farmers are growing curry leaf, onion, chillies and turmeric crops under irrigation.
- Another check dam was constructed on the same drain upside and benefiting the nearby farmers.
- Another check dam seen was breached away and not serving any purpose.
- Another check dam with gate was constructed (about 300 m³) and diverting excess water for irrigation through a small canal. Four wells with five farmers are benefiting and area irrigated is about 10 ha. GWL is increased by about four feet.

Picture 7. Check dam with full of water in Edulapally watershed.

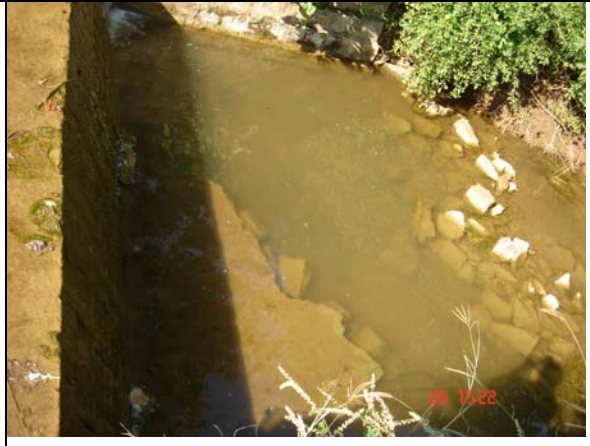
Picture 8. Damaged apron wall of the left side masonry check dam.

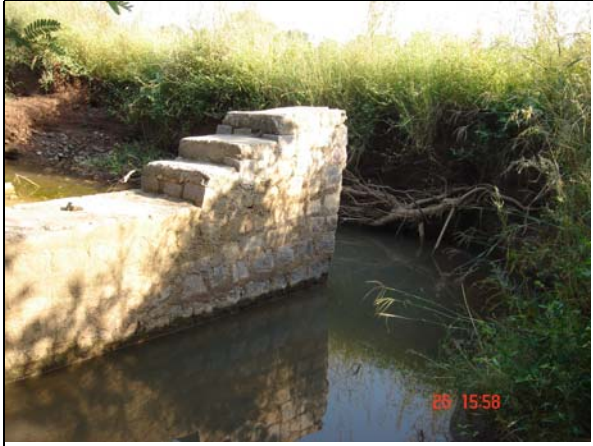
Picture 9. Breached away check dam in Edulapally watershed.

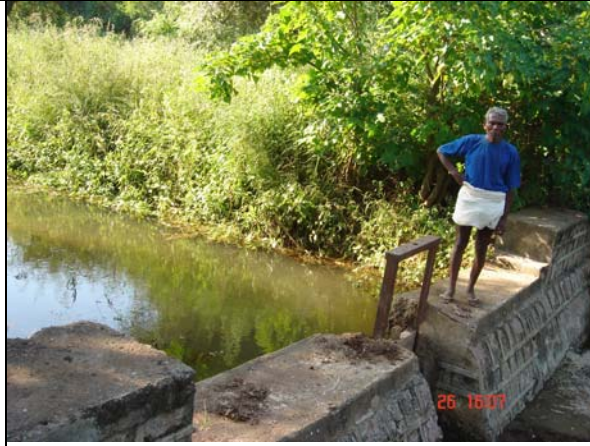
Picture 10. Masonry check dam with a gate to regulate the water release.

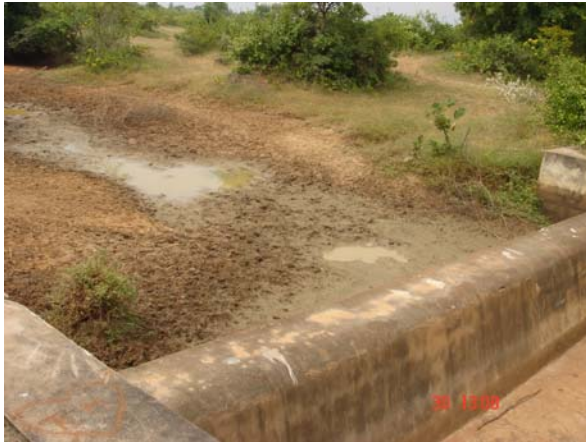
Picture 11. Masonry check dam with accumulated silt in Gadipeddapur watershed.

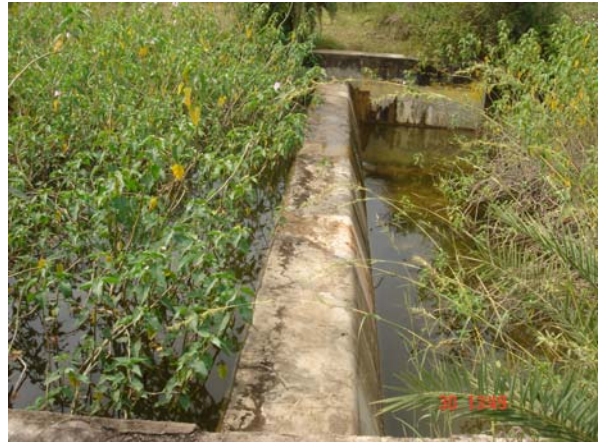
- Masonry check dam with 12 m body wall length, 1.0 m height was seen with storage capacity of about 300 m³ near a tribal hamlet. It is a good structure and serving the purpose. There are about five wells with eight beneficiary farmers and area benefited is about 8 ha. GWL is increased by about two feet and farmers are growing paddy and sugarcane crops under irrigation.
- Another masonry check dam with 12 m body wall length, 1.0 m height with storage capacity of about 800 m³ was visited. It is a good structure with full of

overflowing water but no wells around because of any power supply to that area. Direct pumping with oil engines is done by few nearby farmers to irrigate their crops during moisture stress conditions.

Picture 12. Masonry check dam with overflowing water and grown up bushes in Gadipeddapur watershed.

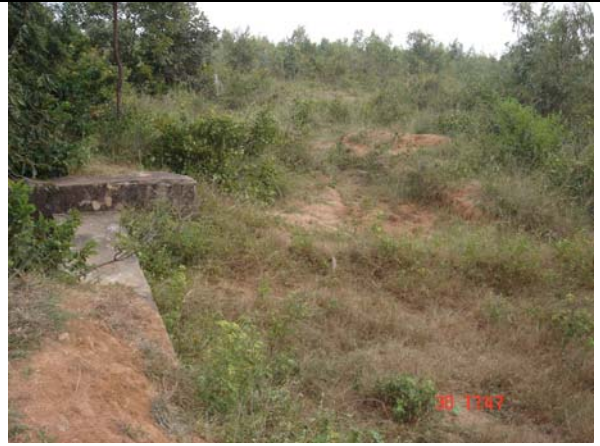
A masonry check dam was constructed in the border of reserve forest land and forest department is not allowing water to store in the structure and no use of it. Body wall of the check dam has become like a bund and soil was put on it and about 3 m body wall only is seen outside. A diversion drain was made to drain out the water from the check dam. This is not at all a suitable location for construction and money is being wasted.

Picture 14. Condition of the masonry check dam constructed in forest land in Lakshmisagar watershed

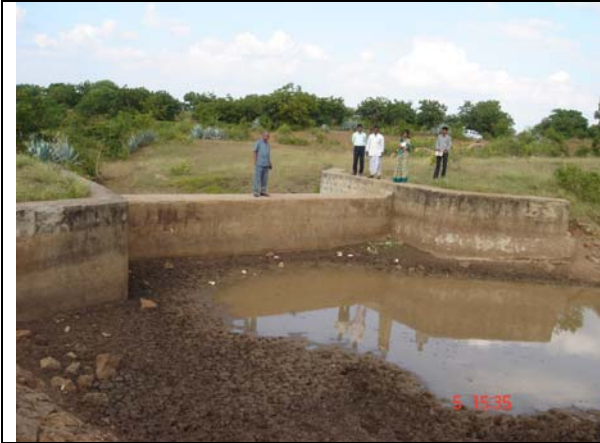
- A masonry check dam with 10 m body wall length and 1.5m height was seen with about 1000 m³ capacity. There are about 7 bore wells with 12 beneficiary farmers around it and about 12 ha area got benefited. Paddy and vegetable crops are grown under irrigation. Good structure, strongly built & no leakages found. Silt accumulation was observed.
- Two numbers of loose boulder structures were seen in the feeder drain of check dam, one structure is slightly damaged and no maintenance of it.
- Two new bore wells were dug near the check dam and good amount of water available in the wells. Pumps are yet to be fixed.

Picture 15. Masonry check dam with stored water and silt accumulation in Maddikunta watershed.

- i. Repair and maintenance of the structures can improve the water availability further in the watershed.
- ii. Promotion of horticultural plantations could have been the better option in long run.

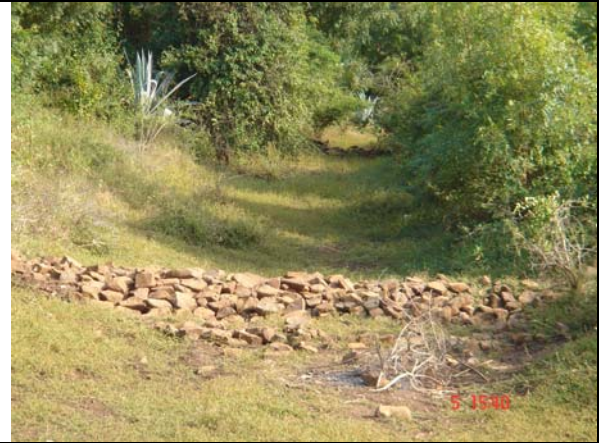
Picture 16. Condition of the damaged loose boulder structure in Maddikunta watershed.

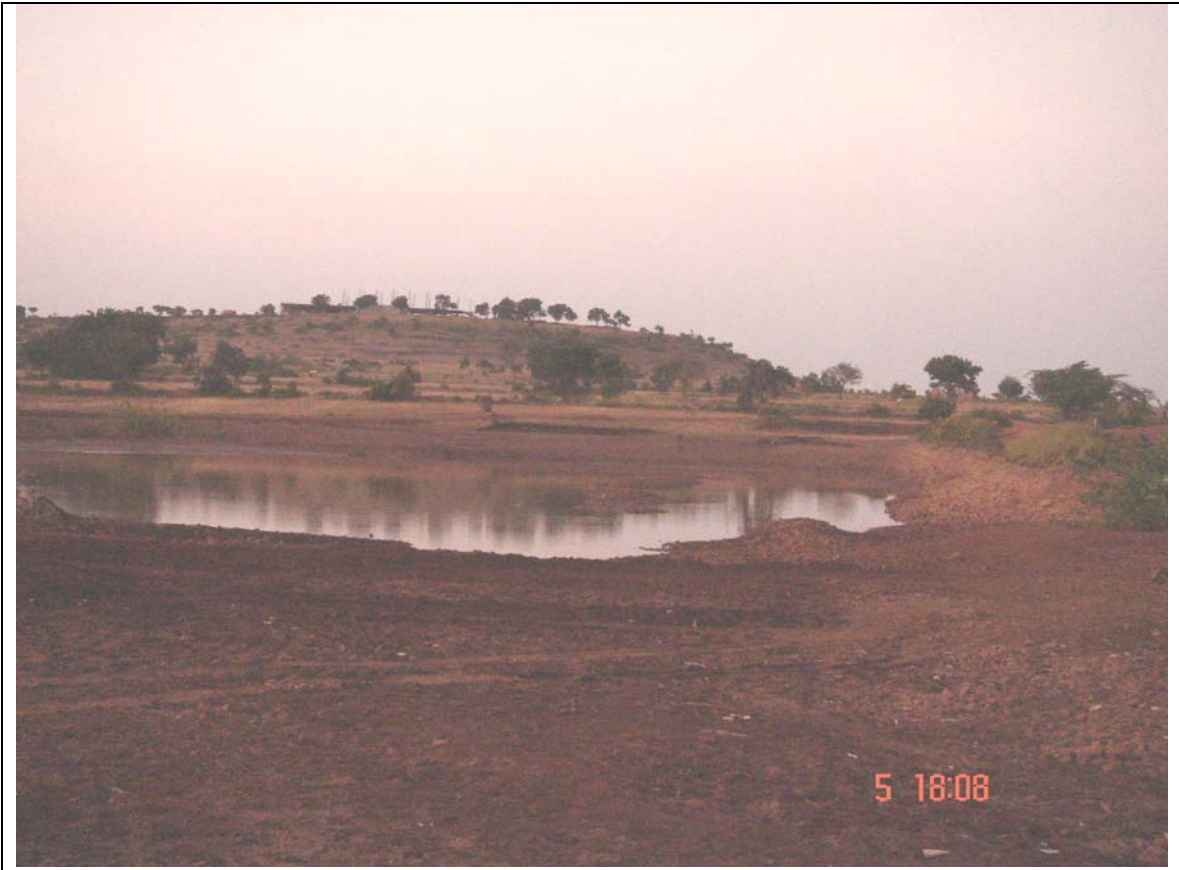
- A percolation tank with about 8000 m³ capacity was seen with about 3000 m³ water stored in it during the field visit. There are three bore wells with three beneficiary farmers and about 3 ha area got benefited. There is considerable rocky area in the down side with less number of wells and less irrigated area in the zone of its influence.

Picture 17. Percolation tank with stored water in it in Mahammadapur watershed.

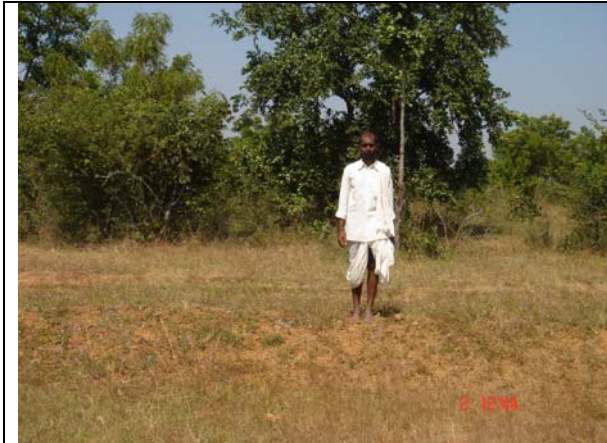
- i. Field bunding along with established *Stylo* fodder and teak plants on the bunds was seen. Teak plants are growing well and will fetch additional income in the form of timber to the farmers after few years.

Picture 18. Stabilized field bunds in the Masanapally watershed.

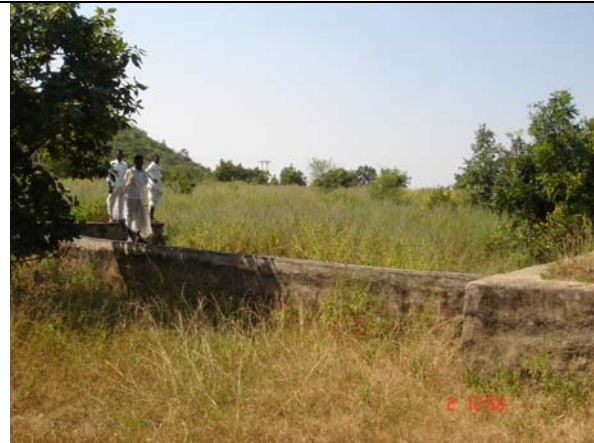
- ii. A masonry check dam with 10 m body wall length and 1 m height with about 400 m³ capacity was inspected. There are eight bore wells with 10 beneficiary farmers and area benefited is about 20 ha. It is effective in recharging the GWL but due to continuous droplets GWL is going down. Farmers felt that field bunding and check dams are effective in recharging groundwater.

Picture 19. Masonry check dam in the Masanapally watershed.

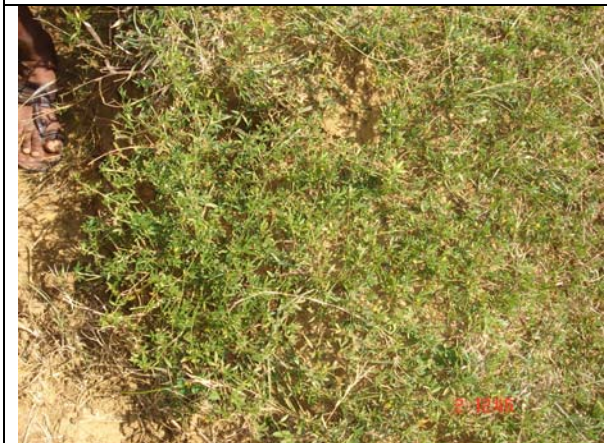
Picture 20. Established Stylo fodder on field bunds in Masanapally watershed.

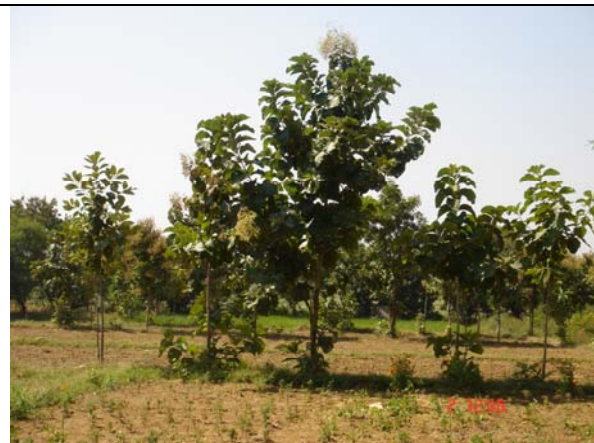
Picture 21. Established teak plants on field bunds in Masanapally watershed.

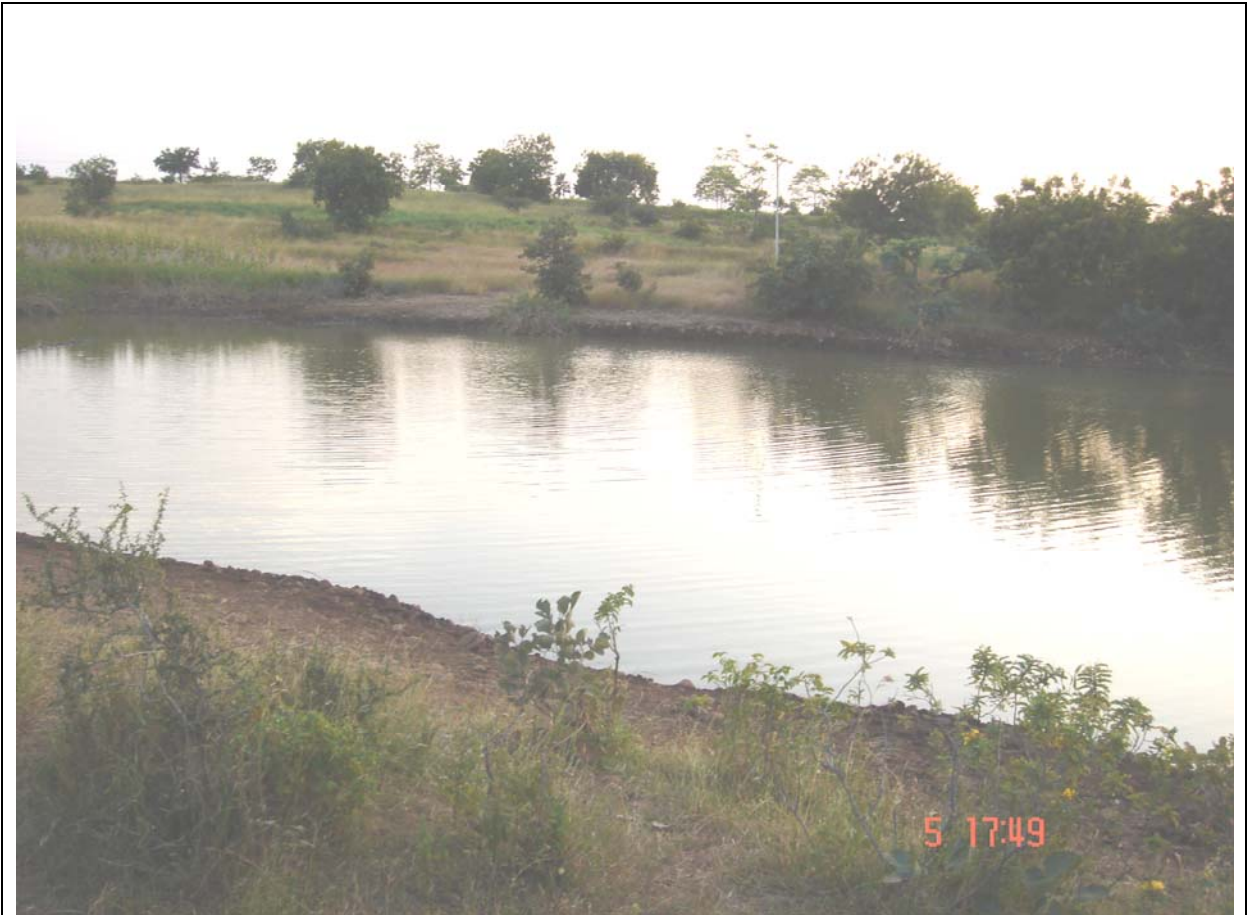
- A percolation tank of about 8000 m³ capacity was seen with about 1000 m³ water stored in it. There are eight bore wells with 15 beneficiary farmers and area benefited is about 12 ha. Good location and good groundwater availability in the wells when there is water stored in the percolation tank.

Picture 22. Good percolation tank with stored water in Gangaram watershed, Medak district.

- i. Horticulture plantations in larger area could have given better income to the farmers.
- ii. Desilting, repair and maintenance of the water harvesting structures can increase water storage and water availability in the bore wells.

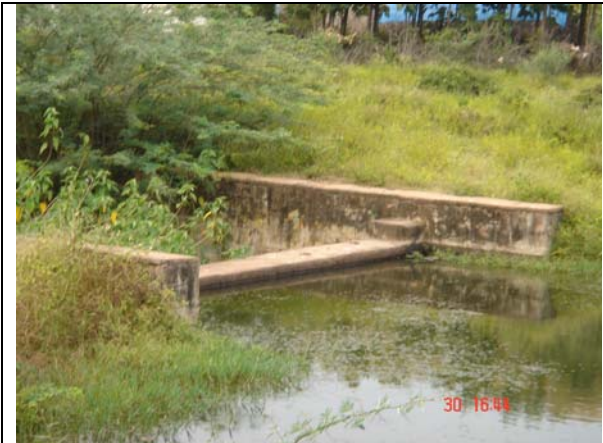
- A masonry check dam of about 400 m³ capacity was seen near school building in the village. It was constructed to recharge groundwater in nearby community bore well for village water supply.
- A masonry check dam of about 800 m³ was seen in the fields near Tummala gadda area. There are four wells with 6 beneficiary farmers and area benefited is about 16 ha. Sugarcane and paddy crops are grown under irrigation and groundnut is grown during rabi after paddy crop. This structure is effective in recharging the groundwater.

Picture 23. Masonry check dam in the Mudimanikyam village constructed for recharging the community bore well.

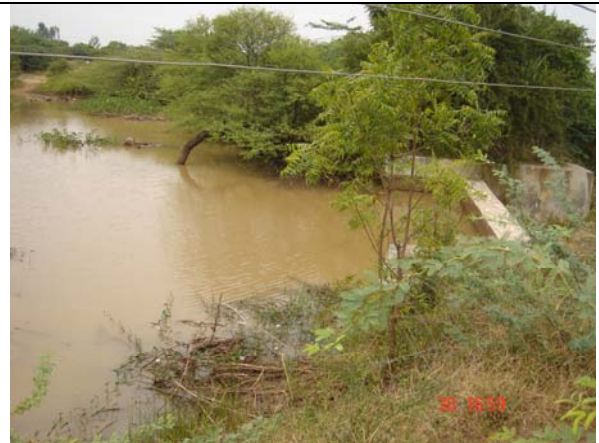
Picture 24. Masonry check dam in the Mudimanikyam watershed effectively recharging the groundwater.

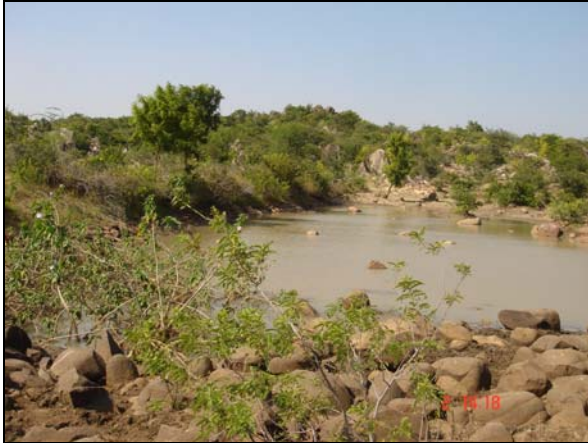
Picture 25. Good percolation tank in the Rayalamadugu watershed.

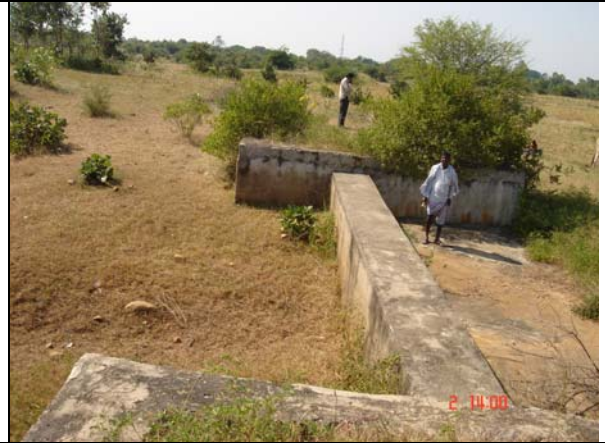
- i. Field bunding is good.
- ii. RFDs are not intact and no maintenance of these structures.
- iii. Masonry check dam was seen with a body wall length of 10m; height of 1 m and size about 400m³. There are five bore wells, five beneficiary farmers and area benefited is about 8 ha. Lot of leakages are observed and no maintenance of the structure.
- iv. A percolation tank of about 1200m³ was seen. There are five bore wells, eight beneficiary farmers and area benefited is about 12 ha. Paddy is grown under irrigation about 100 m away from the pond. Good PT near small hillock and rocky area. About 200 m³ water was stored in it. Serving for cattle drinking. Bore wells are there just after 100 m away from the pond.

Picture 26. Masonry check dam in the Rayalamadugu watershed.

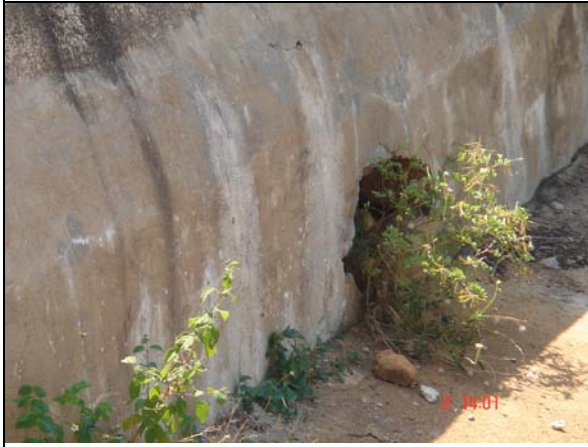
Picture 27. Leakages/damages on masonry check dam in Rayalamadugu watershed.

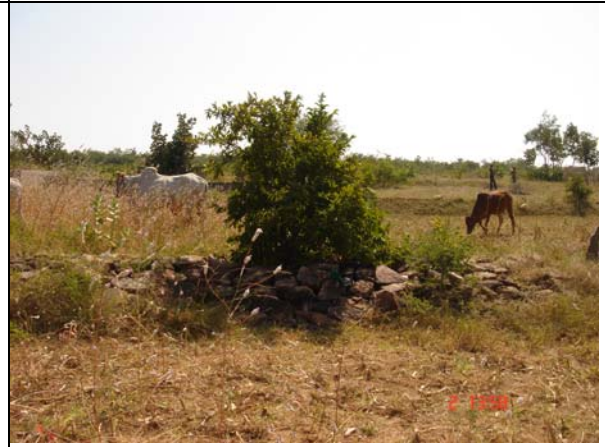
Picture 28. Condition of rock fill dam in the Rayalamadugu watershed.

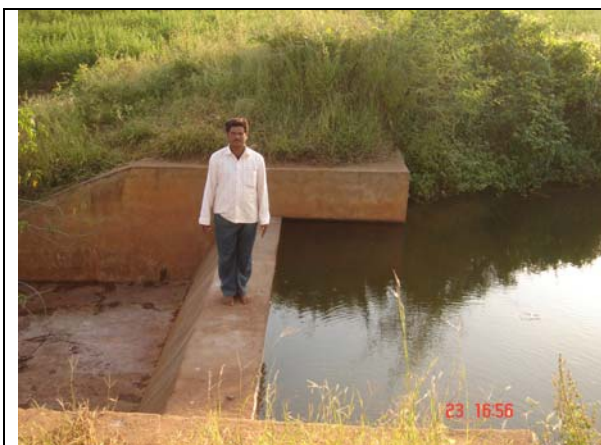
- A masonry check dam with about 200 m³ capacity was seen with full of water. Good structure but no wells and no beneficiary farmers around. Water is useful for cattle drinking and for pesticide sprays on dry land crops. Major dry land crop is pigeonpea in the watershed.
- A percolation tank with about 300 m³ size was seen on the foot of hillock. It is very effective in reducing the soil erosion and recharging the wells in the hamlet.

Picture 29. Masonry check dam in the Sajjaraopet watershed.

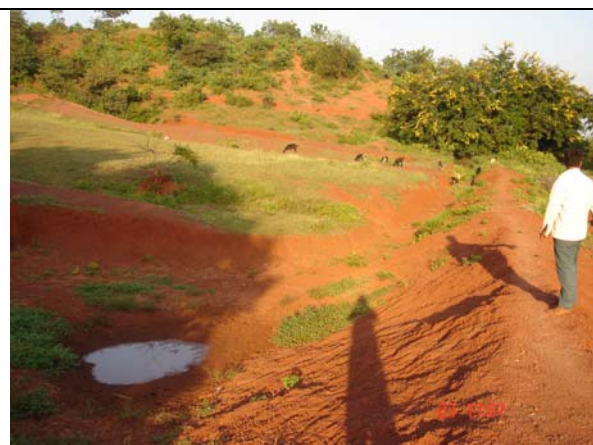
Picture 30. Percolation tank in the Sajjaraopet watershed.

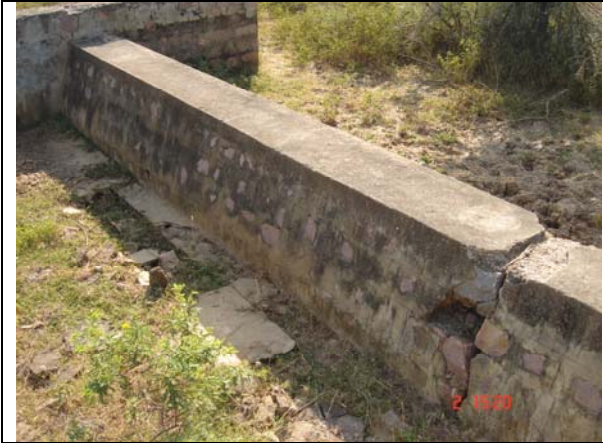
- A masonry check dam measuring 10 m body wall length, 1 m height and about 1000 m³ capacity was seen. There was a big vertical crack on the body wall and water is going out from this. This structure was constructed in uncultivated area and there are no wells and beneficiary farmers around.

Picture 32. Damaged check dam in Sanjeevanraopet watershed serving no purpose.

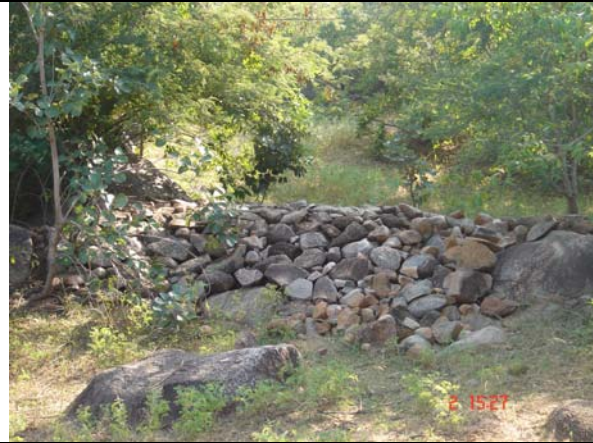
- Field bunding was seen and it is effective in reducing the soil erosion and conserving rain water.
- Rock fill dams and loose boulder structures were seen, some of them were partially damaged and no maintenance of those structures.

Picture 33. Damaged loose boulder structure in Sanjeevanraopet watershed.

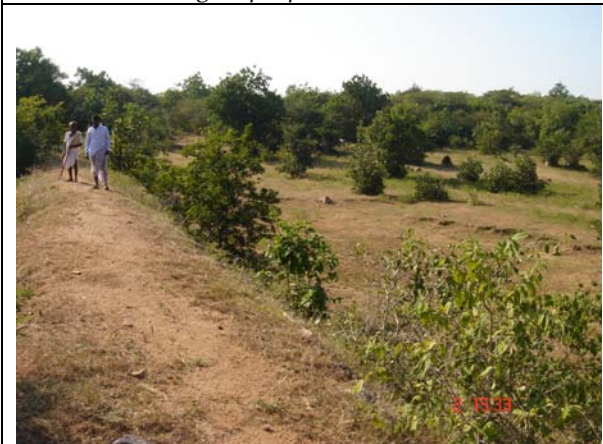
- A percolation tank of about 3000 m³ capacity was seen in fallow area. It is a big tank and down side land was leveled for cultivating paddy crop. But surrounding area is uncultivated land with scrub vegetation. Farmers said that if rains are good and water is stored in the PT, paddy will be cultivated in the downside land. They said that there are some bore wells down side and benefiting some farmers.

Picture 34. Percolation tank constructed in fallow land in Sanjeevanraopet watershed.

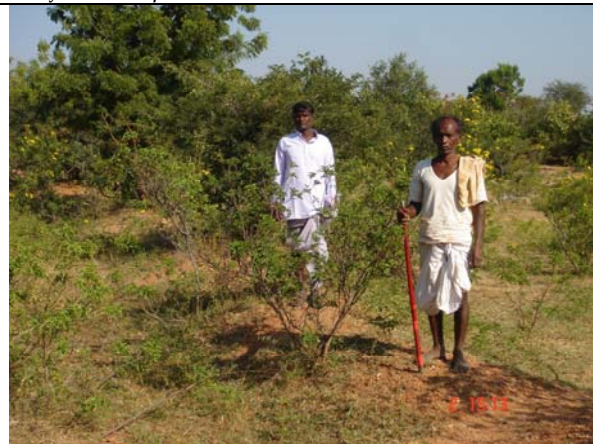
Picture 35. Field bunding done in uncultivated land in Sanjeevanraopet watershed.

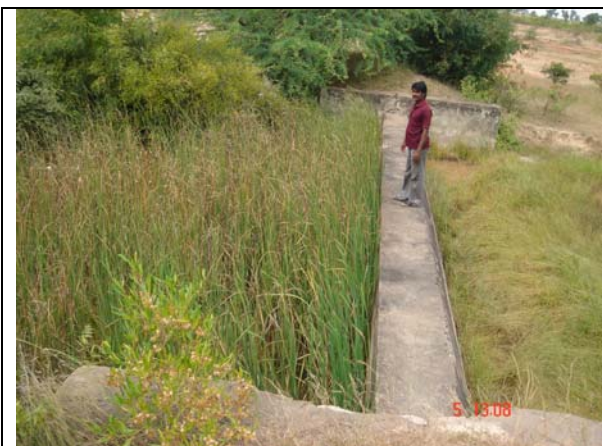
- A masonry check dam was seen in Regintala village with about 400 m³ capacity but silt accumulation has reduced its capacity by 50%. There are three bore wells, five beneficiary farmers and 6 ha area got benefited. Check dam effectiveness has been reduced due to breaching of backside drain. Storage capacity has been reduced drastically.

Picture 36. Masonry check dam in Regintala village, Medak district.

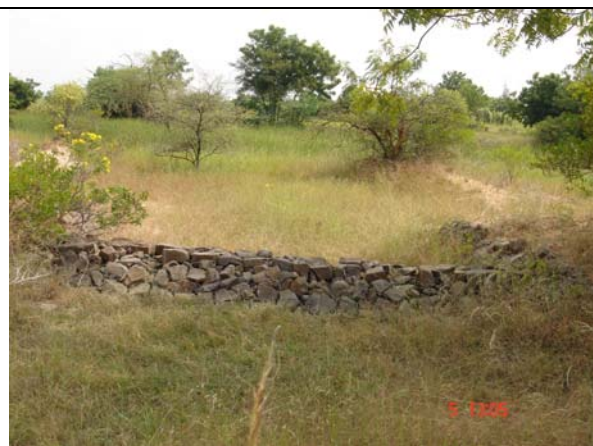
- RFDs and LBS were seen in Regintala village but some are in good condition, some are partially damaged and some are not effective due to breaching of soil from sides. No maintenance of these structures.

Picture 37. Loose boulder structure in Regintala village, Medak district.

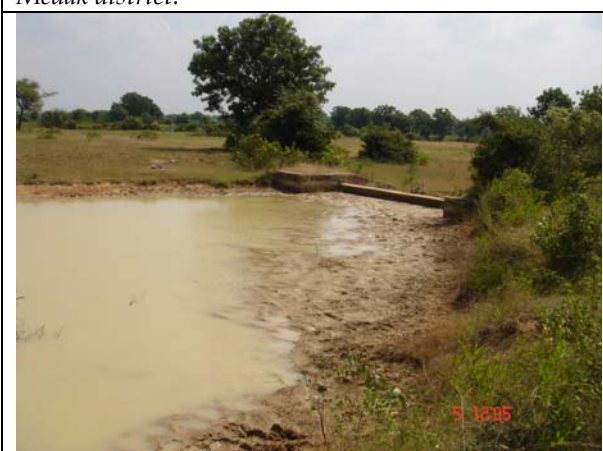
- A masonry check dam was seen in Siddapur village with about 300 m³ capacity but silt deposition has reduced it to about 100 m³. Leakage was observed due to crack on the body wall. Lot of bushes have grown up and reduced its capacity. There are four bore wells, six beneficiary farmers and 4 ha area got benefited.

Picture 38. Masonry check dam with lot of silt accumulation in Siddapur village.

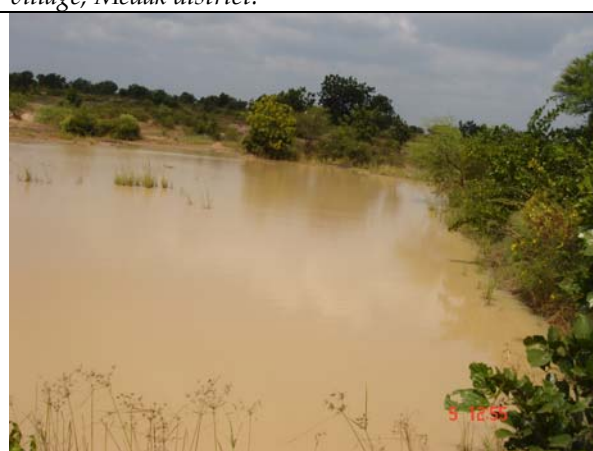
Picture 39. Percolation tank in Regintala village, Medak district.
