Impact Assessment Report
DROUGHT PRONE AREA DEVELOPMENT PROGRAMME
(DPAP-BATCH III)

Nalgonda District, Andhra Pradesh

GLOBAL THEME - AGROECOSYSTEMS

**International Crops Research Institute
for the Semi-Arid Tropics**

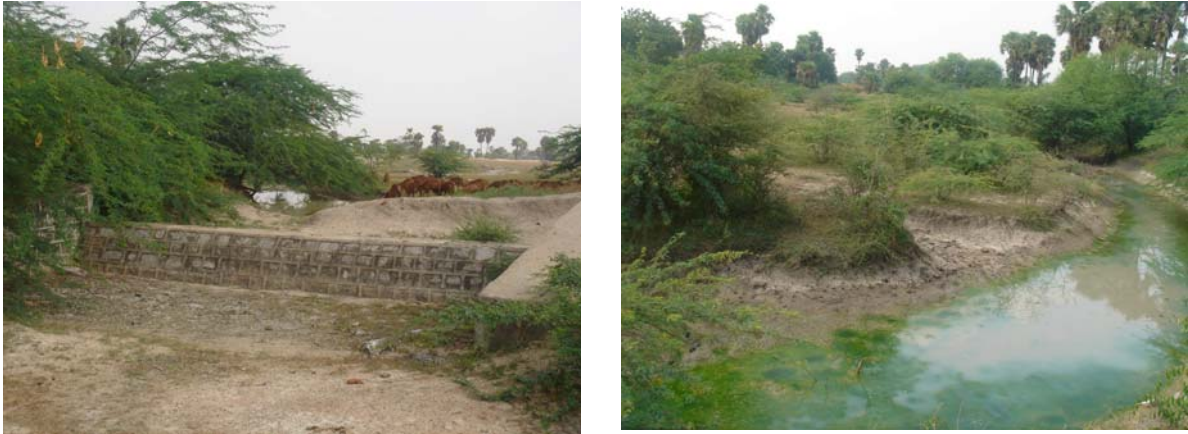
Figure 1. Check dam (left) and percolation tank (right) at Bairavudu watershed, Shaligouraram Mandal.

- The quality of construction and location of WHS is good except two percolation tanks and one check dam that are damaged (**Fig. 1**).
- Maintenance of the structures is very poor and they are filled with sediment and bushes (**Fig.2**).

- Repair, maintenance and de-silting of water harvesting structures are essential to get sustainable benefits.
- Recharging of dry open wells near small streams would have given better equity and results.
- There is a scope for construction of water harvesting structures in untreated area.
- Guidelines are needed for using WDF.

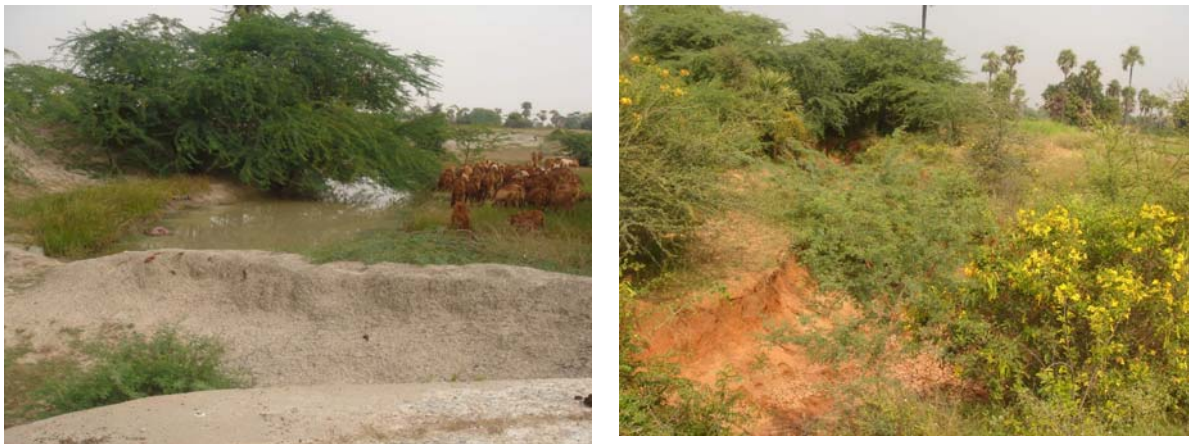
Figure 2. Poor maintenance of the structures at Bairavudu watershed, Shaligouraram Mandal

- Post-project maintenance was not clearly envisaged as an exit policy in the project, hence proper mechanism should be operationalized to repair and maintain the structures, and to ensure proper utilization of WDF/community contribution, clear guidelines should be in place. Otherwise watershed committee exists, but becomes defunct, as is the case with Bairavudu watershed.

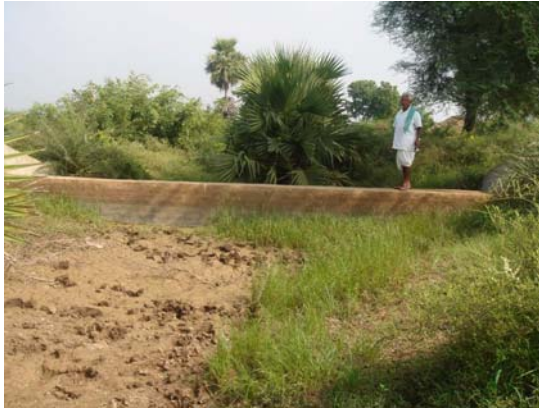
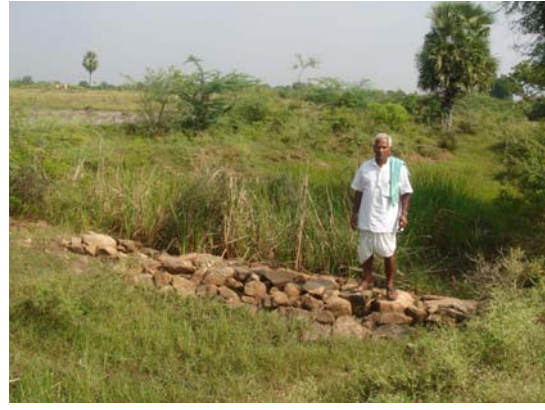
Figure 1. Check dam (left) and gully control structure (right) at Gorekunta watershed, N G Kothapally village, Shaligouraram Mandal.

- Lot of silt accumulation was observed in check dams and no maintenance of the structures (**Fig. 1**).
- Quality of construction of water harvesting structures is poor and damages were noticed (**Fig.2**).

- Repair, maintenance and de-silting of water harvesting structures are essential to get sustainable benefits.
- Horticulture plantations with sweet lime and mango can give better income to the farmers.
- There is a scope for construction of water harvesting structures in untreated area.
- Guidelines are needed for using WDF.

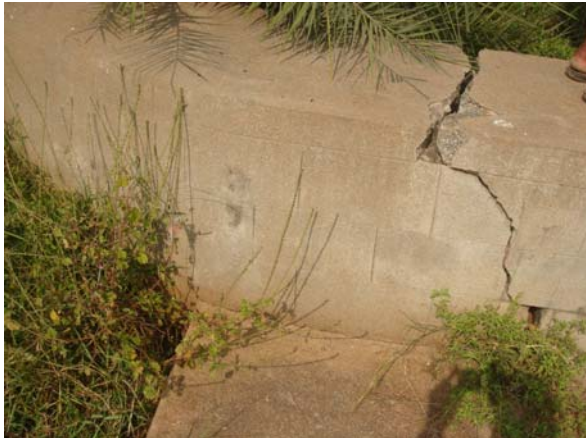
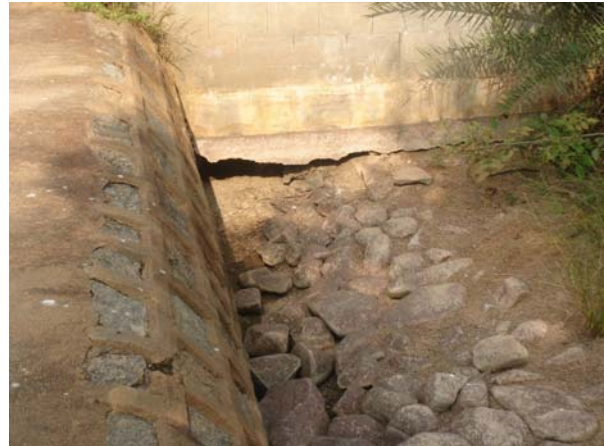
Figure 2. Damages on wing wall and apron wall of check dam, Gorekunta watershed, N G Kothapally village, Shaligouraram Mandal

- Post-project maintenance was not clearly envisaged as an exit policy in the project, hence proper mechanism should be operationalized to repair and maintain the structures, and to ensure proper utilization of WDF/community contribution, clear guidelines should be in place. Otherwise watershed committee exists, but becomes defunct, as is the case with Gorekunta watershed.
- Crop productivity enhancement and water use efficiency measures were not emphasized in the project to harness the full benefits of project activities, and increased water availability.

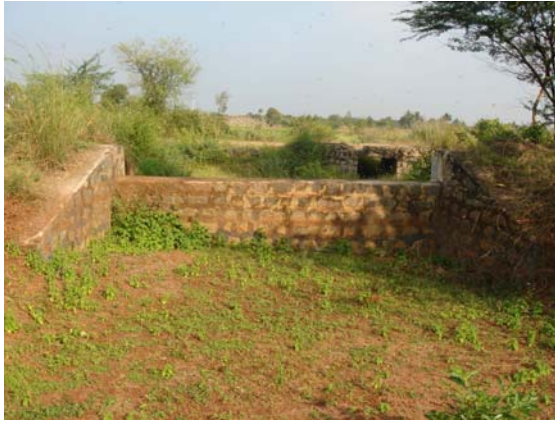
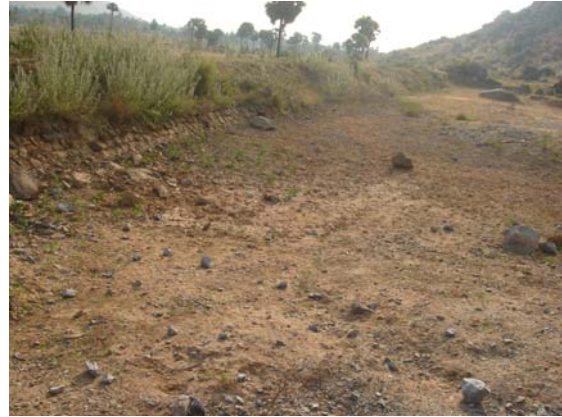
Figure 1. Masonry check dam (left) and percolation tank (right) at Gummadavalli watershed, Thungathuthy Mandal.

- Locations, design criteria and quality of construction of WHS are good and effectively serving the purpose (**Fig. 1**).
- Maintenance of the structures is very poor as they are filled with sediment, bushes and developed leakages (**Fig.2**).

- Repair and maintenance of water harvesting structures are essential to get sustainable benefits.
- De-silting of water harvesting structures is essential to increase storage capacity of the structures.
- There is further scope for horticulture plantations with sweet lime and acid lime.
- There is scope for construction of water harvesting structures in untreated area.
- Guidelines are needed for using WDF.

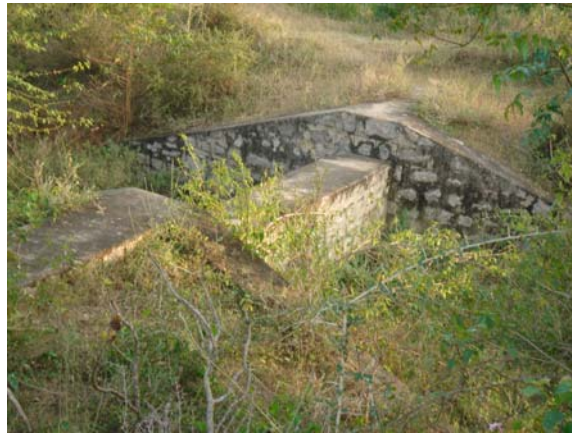
Figure 2. Masonry check filled with bushes at Gummadavalli watershed, Thungathuthy Mandal

- Post-project maintenance was not clearly envisaged as an exit policy in the project, hence proper mechanism should be operationalized to repair and maintain the structures, and to ensure proper utilization of WDF/community contribution, clear guidelines should be in place. Otherwise watershed committee exists, but becomes defunct, as is the case with Gummadavalli watershed.
- Crop productivity enhancement and water use efficiency measures were not emphasized in the project to harness the full benefits of project activities, and increased water availability.

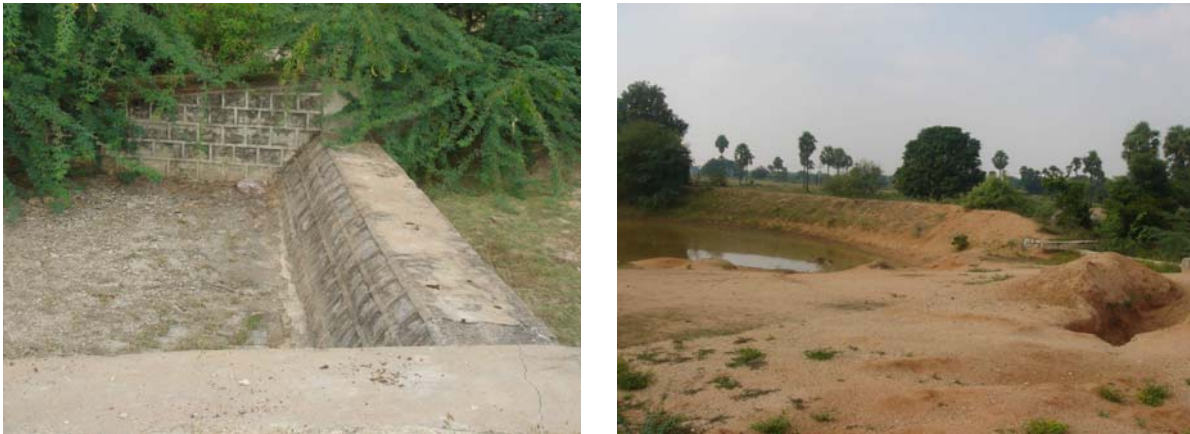
Figure 1. Check dam (left) and percolation tank (right) at Hanuman watershed, Mothey Mandal.

- Locations, design criteria and quality of construction of WHS are good and effectively serving the purpose (**Fig. 1**).
- Maintenance of the structures is very poor as they are filled with sediment, bushes and developed leakages (**Fig.2**).

- Repair, maintenance and de-silting of water harvesting structures are essential to get sustainable benefits.
- Recharging of dry open wells near streams would have given better equity and results.
- There is scope for promoting horticultural plantations with mango and citrus.
- There is a scope for construction of water harvesting structures in untreated area.
- Guidelines are needed for using WDF.

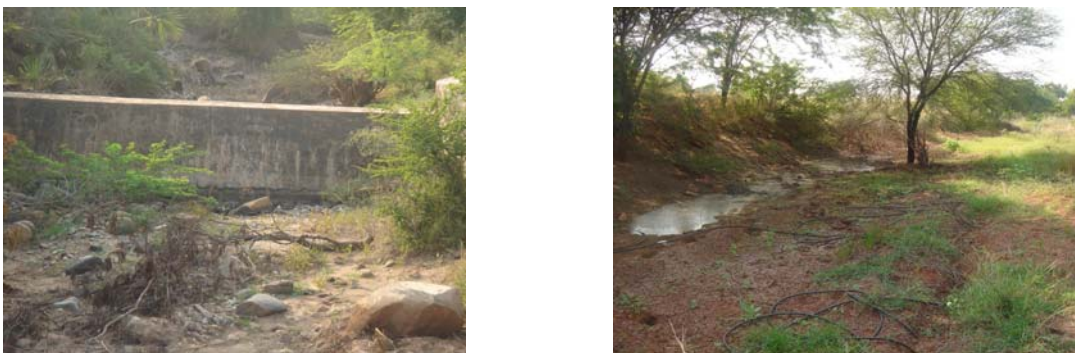
Figure 2. Poor maintenance of the structures at Hanuman watershed, Mothey Mandal

- Post-project maintenance was not clearly envisaged as an exit policy in the project, hence proper mechanism should be operationalized to repair and maintain the structures, and to ensure proper utilization of WDF/community contribution, clear guidelines should be in place. Otherwise watershed committee exists, but becomes defunct, as is the case with Hanuman watershed.
- Crop productivity enhancement and water use efficiency measures were not emphasized in the project to harness the full benefits of project activities, and increased water availability.

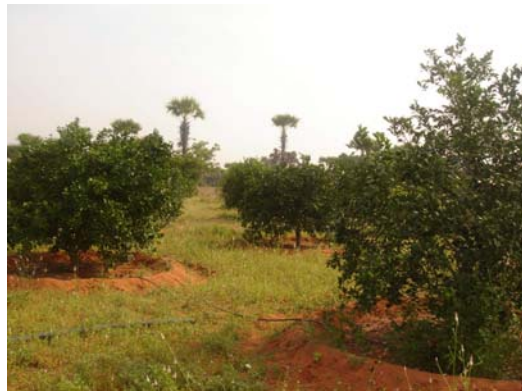
Figure 3. Diversified sweet lime cultivation with drip irrigation in Hanuman watershed.

- **Many farmers** in the village have diversified their crops to sweet lime with drip irrigation due to watershed interventions and increased groundwater availability to have more secured and sustainable incomes (Fig. 3).

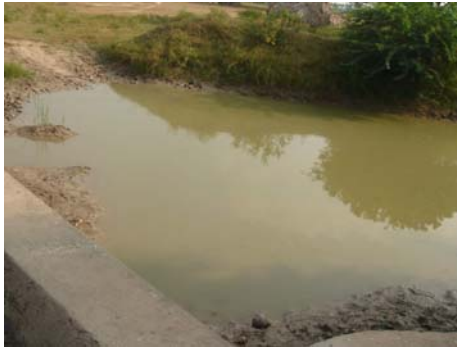
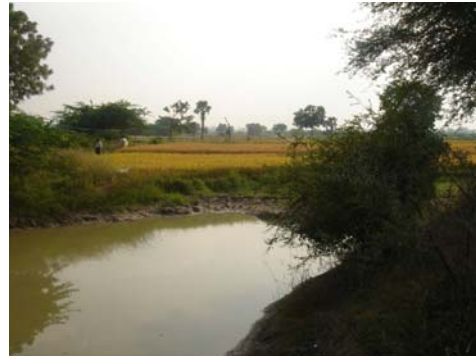
Figure 1. Masonry check dam (left) and good paddy crop near a check dam (right) at Jammikunta watershed, Shaligouraram Mandal.

- Locations and design criteria of the check dams are good and serving the purpose (Fig. 1).
- Quality of construction of the water harvesting structures is not that good, no maintenance of the structures and damaged structures are ineffective in serving the purpose (Fig.2).

- Repair and maintenance of water harvesting structures are essential to get sustainable benefits.
- Removal of bushes and de-silting of water harvesting structures is essential to increase storage capacity of the structures.
- There is further scope for horticulture plantations with sweet lime and acid lime.
- There is scope for construction of water harvesting structures in untreated area.

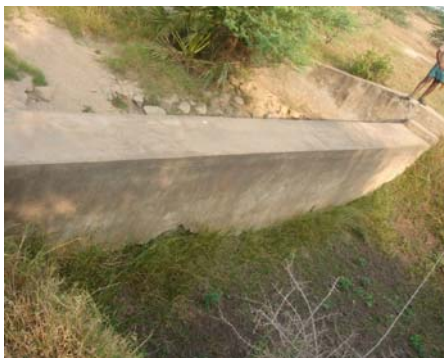
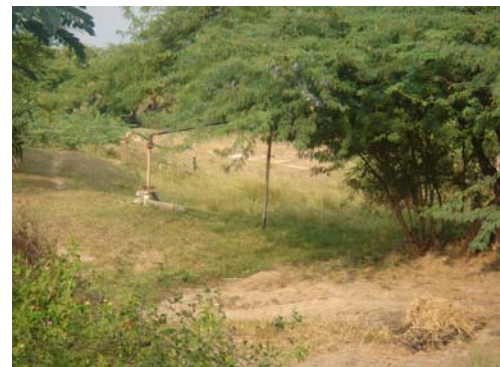
Figure 2. Damages on apron wall, leakages from check dam and grown up bushes, silt deposition in the structures at Jammikunta watershed, Shaligouraram Mandal

- Post-project maintenance was not clearly envisaged as an exit policy in the project, hence proper mechanism should be operationalized to repair and maintain the structures, and to ensure proper utilization of WDF/community contribution, clear guidelines should be in place. Otherwise watershed committee exists, but becomes defunct, as is the case with Jammikunta watershed.
- Crop productivity enhancement and water use efficiency measures were not emphasized in the project to harness the full benefits of project activities, and increased water availability.

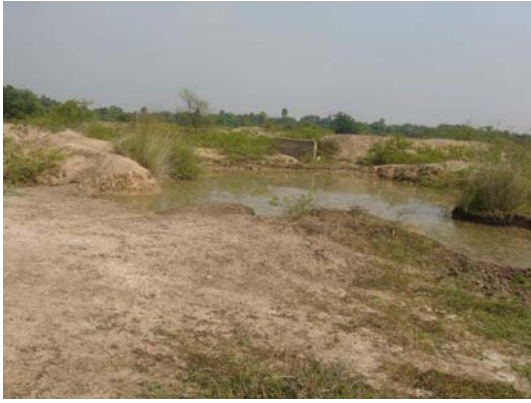
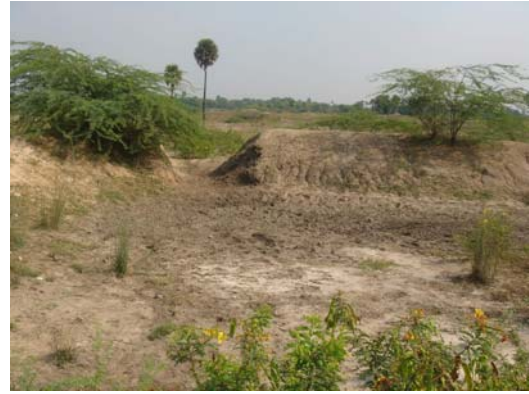
Figure 1. Damaged check dam (left) and damaged percolation tank (right) at Kandikunta watershed, N G Kothapally village, Shaligouraram Mandal.

- Water harvesting structures were constructed in saline soil area and most of them are damaged (**Fig. 1**).
- Quality of construction of water harvesting structures is poor and damaged structures are not serving any purpose (**Fig.2**).

- Repair, maintenance and de-silting of water harvesting structures are essential to get sustainable benefits.
- Horticulture plantations with sweet lime and mango can give better income to the farmers.
- There is a scope for construction of water harvesting structures in untreated area.
- Guidelines are needed for using WDF.

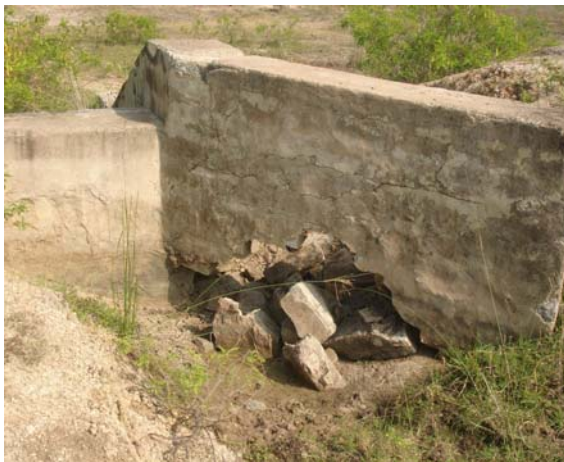
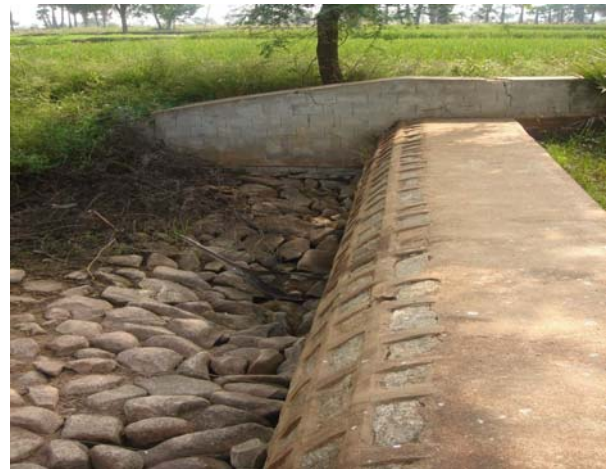
Figure 2. A big hole on wing wall (left) and damage on apron wall (right) of check dams, Kandikunta watershed, N G Kothapally village, Shaligouraram Mandal

- Post-project maintenance was not clearly envisaged as an exit policy in the project, hence proper mechanism should be operationalized to repair and maintain the structures, and to ensure proper utilization of WDF/community contribution, clear guidelines should be in place. Otherwise watershed committee exists, but becomes defunct, as is the case with Kandikunta watershed.

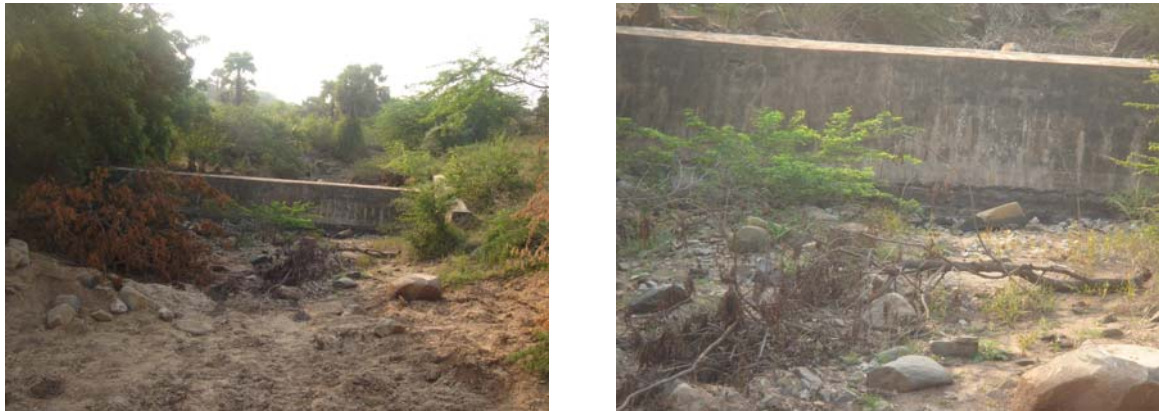
Figure 1. Masonry check dam (left) and damaged apron wall with leakages (right) at Karshak watershed, Akaram village, Shaligouraram Mandal

- Locations of the check dams are good but quality of construction is very poor. Apron walls are completely damaged and leakages are reported by nearby beneficiary farmers and not much useful now **(Fig. 1)**.
- Bund strengthening with stone revetment was done and surplus weirs were constructed to two existing percolation tanks **(Fig.2)**. Surplus weirs are controlling soil erosion but necessity and relevance of bund strengthening and revetment work was big question mark.

- Repair and maintenance of water harvesting structures are essential to get sustainable benefits.
- De-silting of water harvesting structures is essential to increase storage capacity of the structures.

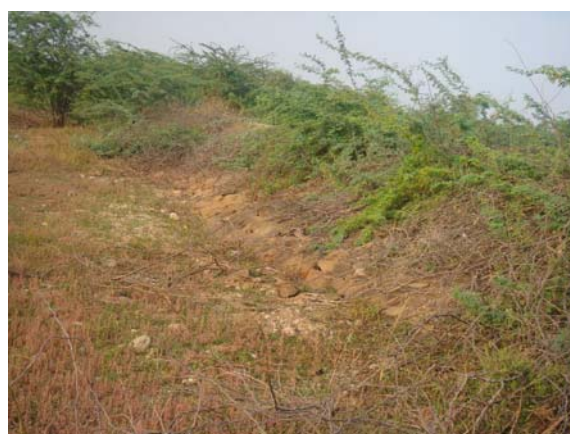
Figure 2. Percolation tank with stone revetment at Karshak watershed, Akaram village, Shaligouraram Mandal

- Post-project maintenance was not clearly envisaged as an exit policy in the project, hence proper mechanism should be operationalized to repair and maintain the

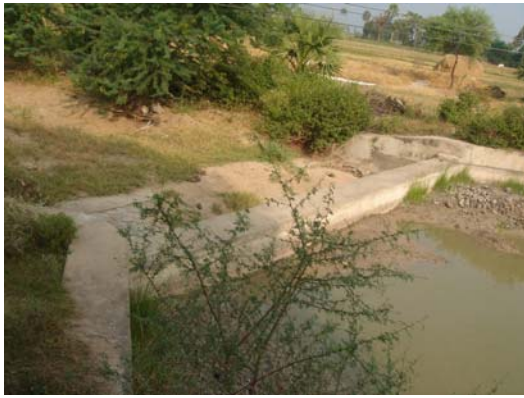
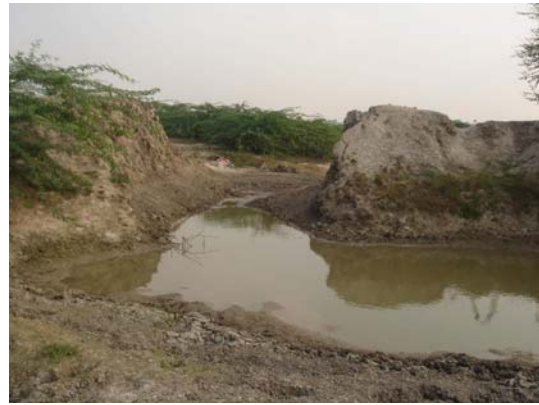
Figure 1. Masonry check dam (left) and damaged percolation tank (right) at Kisan watershed, Adloor village, Shaligouraram Mandal.

- Locations of the check dams are good but maintenance is poor. Where as percolation tank was constructed in saline soil area, bund is breached away and there are no beneficiaries or cultivable area near by PT **(Fig. 1)**.
- Quality of construction of water harvesting structures is poor and damaged structures are not serving any purpose **(Fig.2)**.

- Repair and maintenance of water harvesting structures are essential to get sustainable benefits.
- De-silting of water harvesting structures is essential to increase storage capacity of the structures.
- There is further scope for horticulture plantations with sweet lime and acid lime.
- There is scope for construction of water harvesting structures in untreated area.
- Guidelines are needed for using WDF.

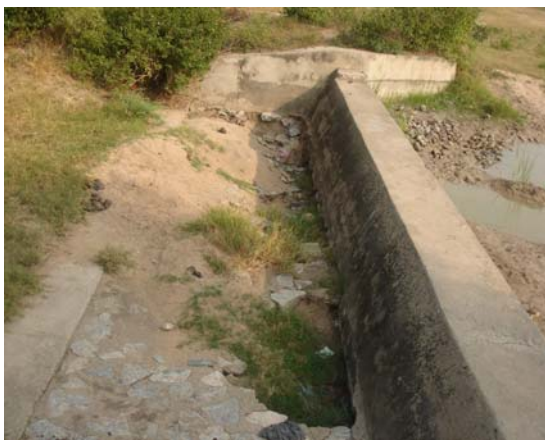
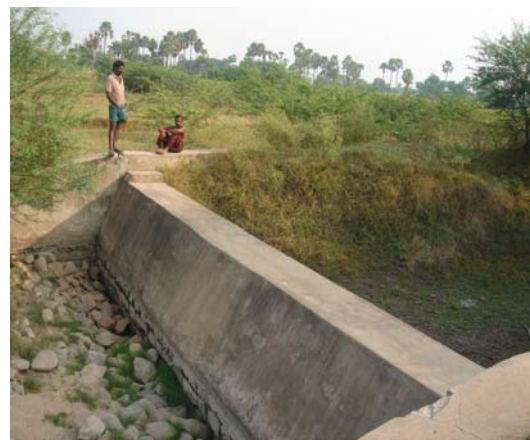
Figure 2. Damages on apron walls and leakages from check dams, Kisan watershed, Adloor village, Shaligouraram Mandal

- Post-project maintenance was not clearly envisaged as an exit policy in the project, hence proper mechanism should be operationalized to repair and maintain the structures, and to ensure proper utilization of WDF/community contribution, clear guidelines should be in place. Otherwise watershed committee exists, but becomes defunct, as is the case with Kisan watershed.

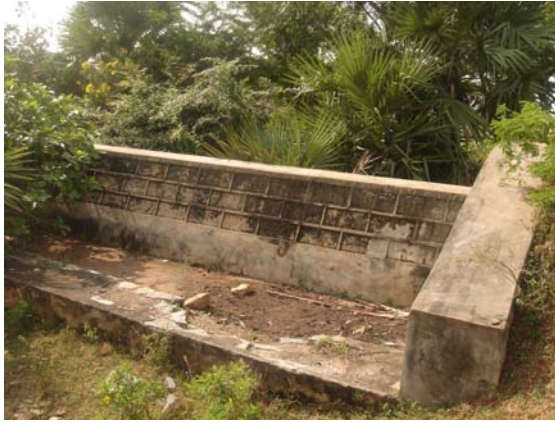
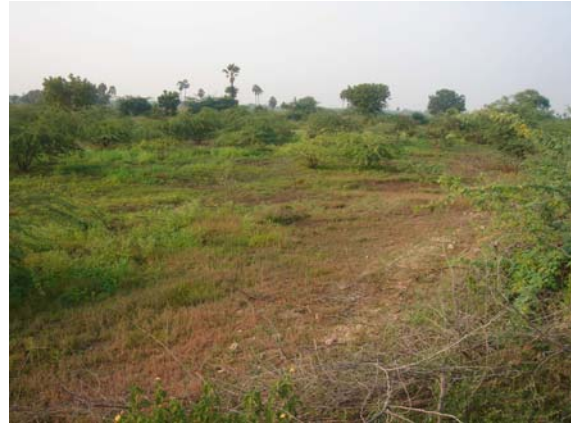
Figure 1. Check dam (left) and percolation tank (right) at Kudali watershed, Mothey Mandal

- Locations, design criteria and quality of construction of WHS are good and effectively serving the purpose (**Fig. 1**).
- Maintenance of the structures is very poor and they are filled with sediment and bushes (**Fig.2**).

- Repair, maintenance and de-silting of water harvesting structures are essential to get sustainable benefits.
- Recharging of dry open wells near streams would have given better equity and results.
- There is scope for promoting horticultural plantations with mango and citrus.
- There is a scope for construction of water harvesting structures in untreated area.
- Guidelines are needed for using WDF.

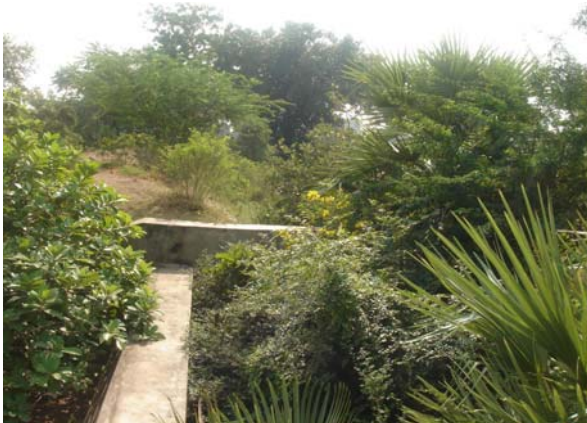
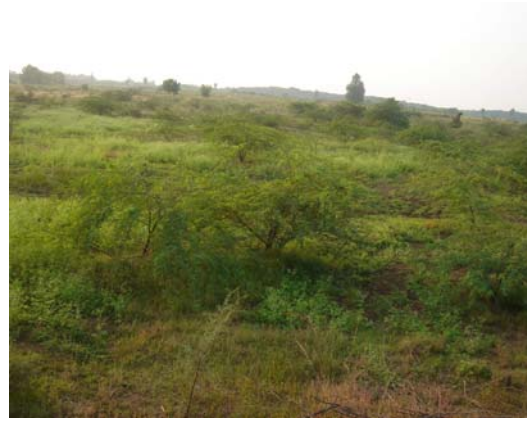
Figure 2. Poor maintenance of the structures at Kudali watershed, Mothey Mandal

- Post-project maintenance was not clearly envisaged as an exit policy in the project, hence proper mechanism should be operationalized to repair and maintain the structures, and to ensure proper utilization of WDF/community contribution, clear guidelines should be in place. Otherwise watershed committee exists, but becomes defunct, as is the case with Kudali watershed.
- Crop productivity enhancement and water use efficiency measures were not emphasized in the project to harness the full benefits of project activities, and increased water availability.

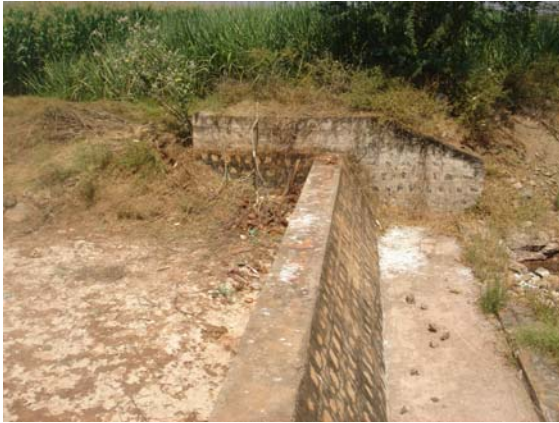
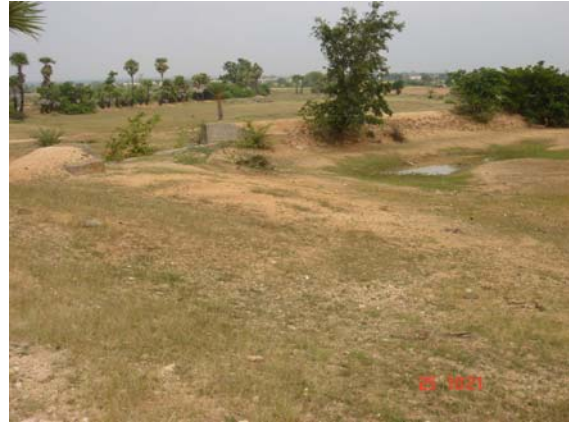
Figure 1. Check dam (left) and percolation tank (right) at Neredavai watershed, Mothey Mandal.

- Locations, design criteria and quality of construction of WHS are good and effectively serving the purpose (**Fig. 1**).
- Maintenance of the structures is very poor; they are filled with sediment, bushes and damages were noticed (**Fig.2**).

- Repair, maintenance and de-silting of water harvesting structures are essential to get sustainable benefits.
- Recharging of dry open wells near streams would have given better equity and results.
- There is scope for promoting horticultural plantations with mango and citrus.
- There is a scope for construction of water harvesting structures in untreated area.
- Guidelines are needed for using WDF.

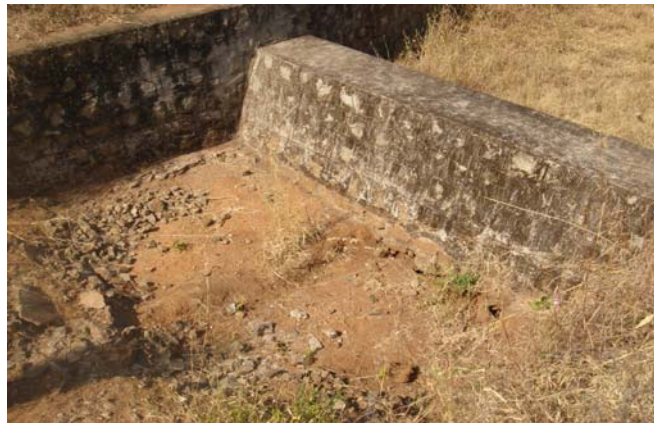
Figure 2. Damage of apron wall at Neredavai watershed, Mothey Mandal

- Post-project maintenance was not clearly envisaged as an exit policy in the project, hence proper mechanism should be operationalized to repair and maintain the structures, and to ensure proper utilization of WDF/community contribution, clear guidelines should be in place. Otherwise watershed committee exists, but becomes defunct, as is the case with Neredavai watershed.

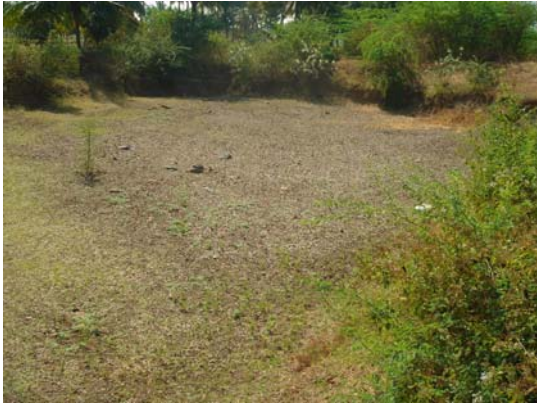
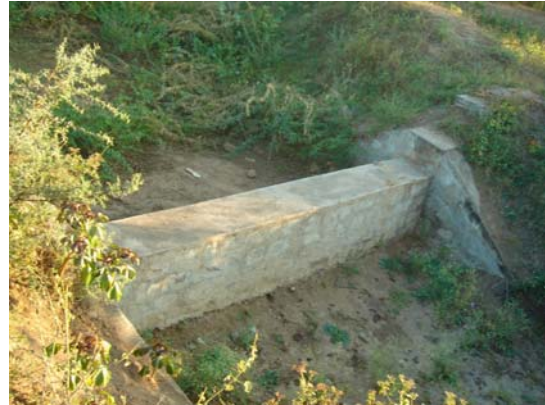
Figure 1. Percolation tank (left) and Masonry check dam (right) at Peddacheruvu watershed, Shaligouraram Mandal.

- Locations, design criteria and quality of construction of check dams are good and serving the purpose (**Fig. 1**).
- Bund strengthening was done and surplus weirs were constructed to the existing percolation tanks in the watershed.
- Water harvesting structures are filled with bushes, sediment and developed leakages; hence efficiency and effectiveness of the structures are reduced (**Fig.1&2**).

- Repair and maintenance of water harvesting structures are essential to get sustainable benefits.
- De-silting of water harvesting structures is essential to increase storage capacity of the structures.
- There is further scope for horticulture plantations with sweet lime and acid lime.
- There is scope for construction of water harvesting structures in untreated area.
- Guidelines are needed for using WDF.

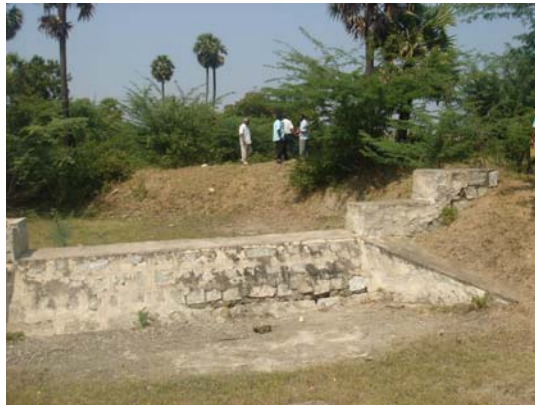
Figure 2. Leakages from check dam at Peddacheruvu watershed, Shaligouraram Mandal

- Post-project maintenance was not clearly envisaged as an exit policy in the project, hence proper mechanism should be operationalized to repair and maintain the structures, and to ensure proper utilization of WDF/community contribution, clear guidelines should be in place. Otherwise watershed committee exists, but becomes defunct, as is the case with Peddacheruvu watershed.

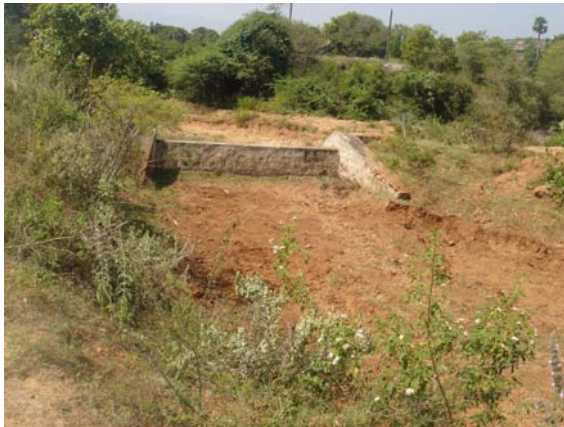
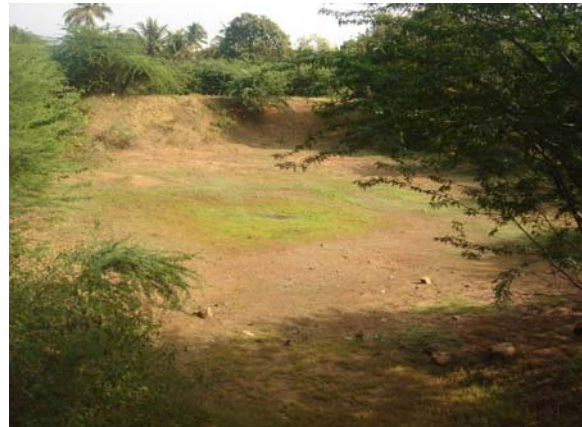
Figure 1. Check dam (left) and percolation tank (right) at Rama watershed, Mothey Mandal.

- Locations, design criteria and quality of construction of WHS are good and effectively serving the purpose (**Fig. 1**).
- Maintenance of the structures is very poor as damages and leakages were observed (**Fig.2**).

- Repair, maintenance and de-silting of water harvesting structures are essential to get sustainable benefits.
- Recharging of dry open wells near streams would have given better equity and results.
- There is scope for promoting horticultural plantations with mango and citrus.
- There is a scope for construction of water harvesting structures in untreated area.
- Guidelines are needed for using WDF.

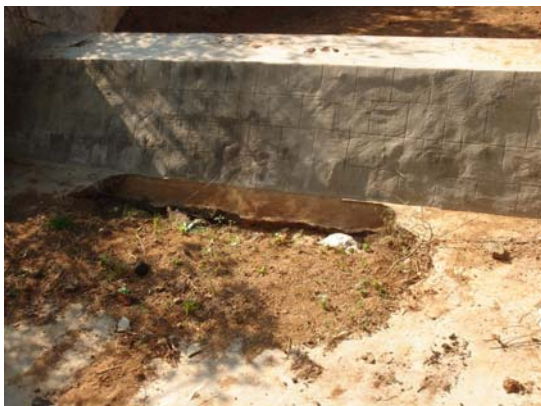
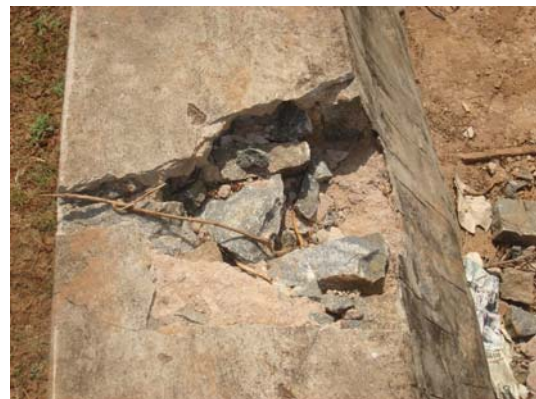
Figure 2. Poor maintenance of the structures at Rama watershed, Mothey Mandal

- Post-project maintenance was not clearly envisaged as an exit policy in the project, hence proper mechanism should be operationalized to repair and maintain the structures, and to ensure proper utilization of WDF/community contribution, clear guidelines should be in place. Otherwise watershed committee exists, but becomes defunct, as is the case with Rama watershed.
- Crop productivity enhancement and water use efficiency measures were not emphasized in the project to harness the full benefits of project activities, and increased water availability.

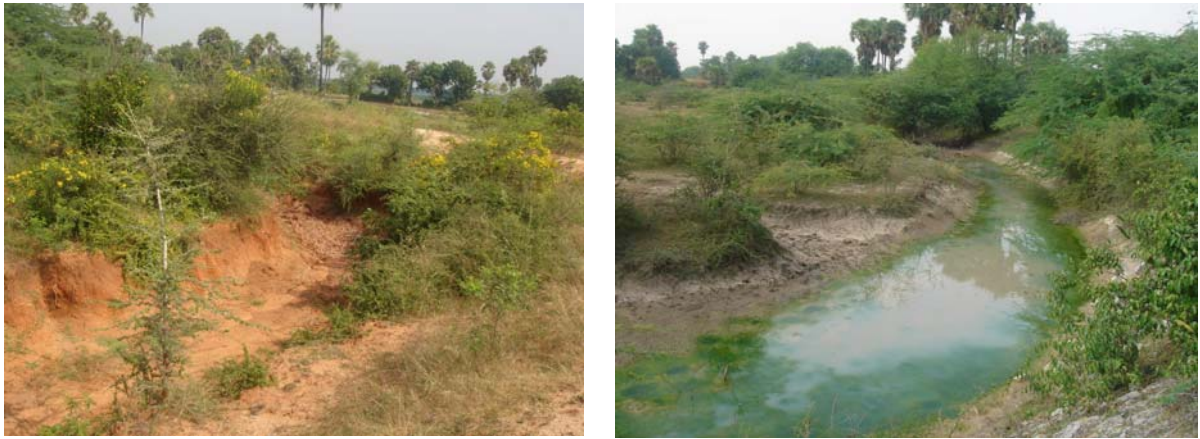
Figure 1. Percolation tanks at Shikamcheruvu watershed, Shaligouraram Mandal.

- The quality of construction and location of WHS is good and serving the purpose (Fig. 1).
- Maintenance of the structures is poor as they are filled with sediment and bushes (Fig.2).

- Repair, maintenance and de-silting of water harvesting structures are essential to get sustainable benefits.
- Recharging of dry open wells near small streams would have given better equity and results.
- There is a scope for construction of water harvesting structures in untreated area.
- Guidelines are needed for using WDF.

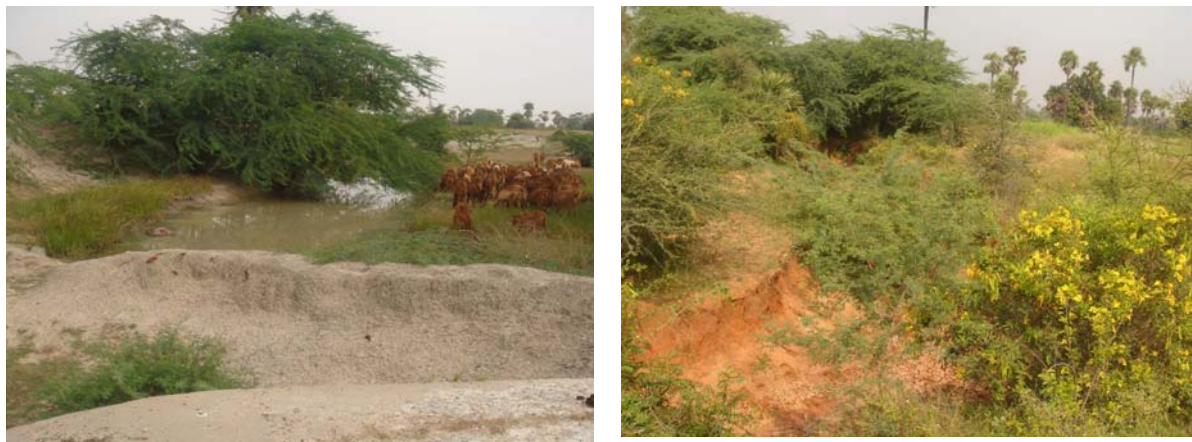
Figure 2. Poor maintenance of the structures at Shikamcheruvu watershed, Shaligouraram Mandal

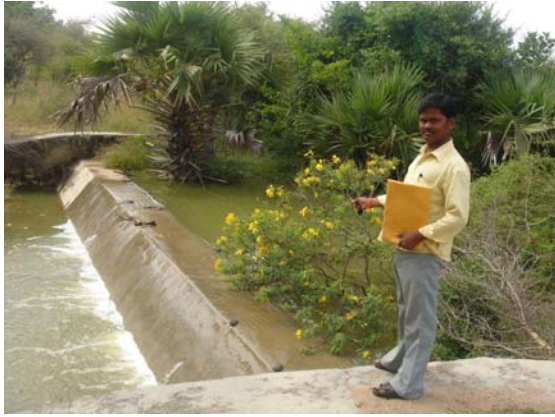
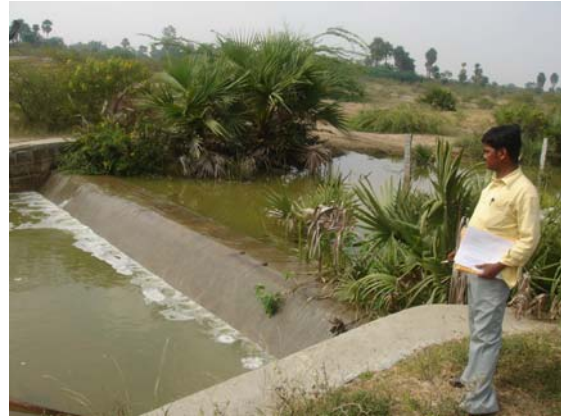
Figure 1. Check dams at Voorakunta watershed, Takkellapadu village, Shaligouraram Mandal.

- The quality of construction and location of WHS is good and water was flowing in the canal as the water was released from Akkenapally tank to fill up Akaram tank **(Fig. 1)**.
- Damage on apron wall and grown bushes were noticed in the check dams and lot of fallow land with bushes exist on left side of the structures **(Fig.2)**.

- Repair, maintenance and de-silting of water harvesting structures are essential to get sustainable benefits.
- Recharging of dry open wells near small streams would have given better equity and results.
- There is a scope for construction of water harvesting structures in untreated area.
- Guidelines are needed for using WDF.

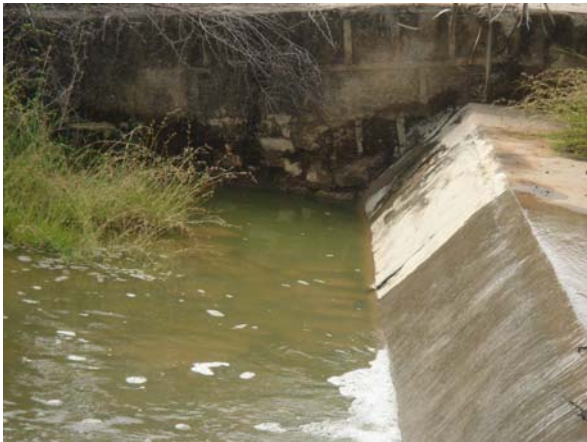
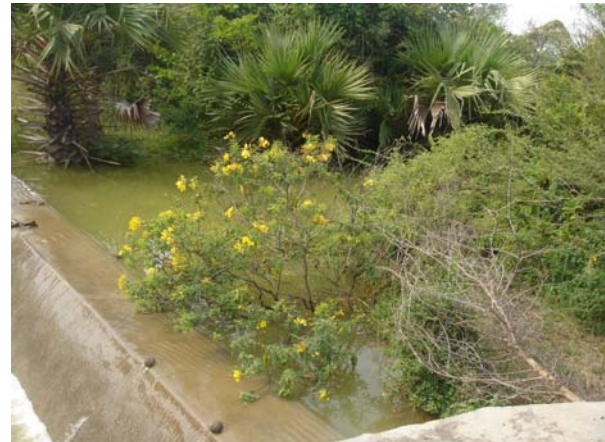
Figure 2. Damage on apron wall and encroachment of bushes in check dams, Voorakunta watershed

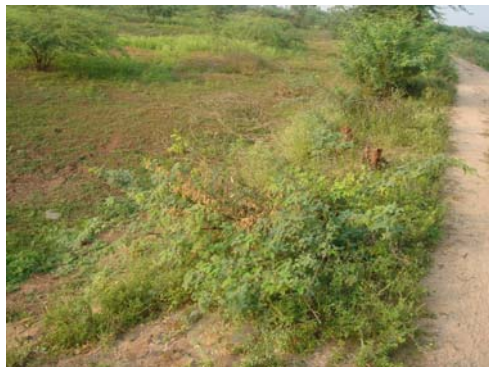
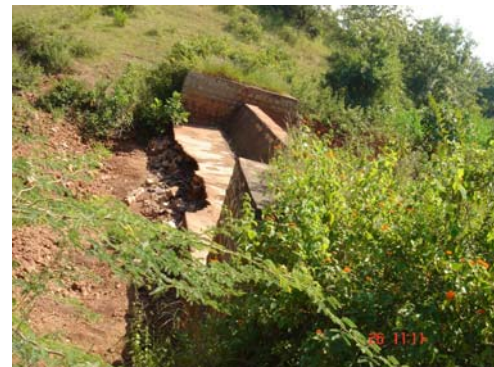
Figure 1. Percolation tank (left) and Masonry check dam (right) at Yerrakunta watershed, Shaligouraram Mandal.

- Locations of the WHS are good but quality of construction of check dams is not that good (**Fig. 1**).
- Bund strengthening with stone revetment was done to existing percolation tanks.
- Apron walls are damaged and leakages are reported by nearby farmers and not much useful now (**Fig. 1&2**).

- Repair and maintenance of water harvesting structures are essential to get sustainable benefits.
- De-silting of water harvesting structures is essential to increase storage capacity of the structures.
- There is further scope for horticulture plantations with sweet lime and acid lime.
- There is scope for construction of water harvesting structures in untreated area.
- Guidelines are needed for using WDF.

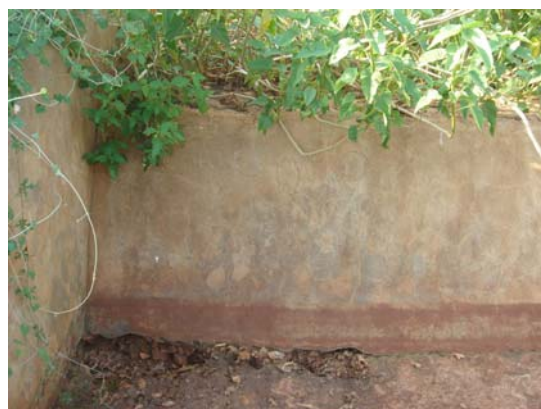
Figure 2. Leakage from check dam at Yerrakunta watershed, Shaligouraram Mandal
